# CALIFORNIA EXPANDED METAL COMPANY (CEMCO) ACOUSTICAL PERFORMANCE TEST REPORT

ASTM E90 SOUND TRANSMISSION LOSS TESTING ON A WALL SYSTEM WITH 3-5/8" STEEL STUDS SPACED 24"OC WITH RC1-XD RESILIENT CHANNEL ON INTERIOR SPACED 24" OC, ONE LAYER 5/8" USG TYPE X SOURCE (SCREW SPACING 8" ON PERIMETER 12" IN THE FIELD)/TWO LAYERS 5/8" USG TYPE X RECEIVE (SCREW SPACING 12"OC)

M0013.01-303-11-R1

<b>TYPE</b>	Wall System
<b>SERIES/MODEL</b>	3-5/8" Steel Studs spaced 24"OC with RC1-XD Resilient Channel on Interior spaced 24" OC, One Layer 5/8" USG Type X Source (screw spacing 8" on perimeter 12" in the field)/Two Layers 5/8" USG Type X Receive (screw spacing 12"OC)
<b>DATA FILE NO.</b>	M0013.01
<b>STC</b>	57
<b>OITC</b>	38

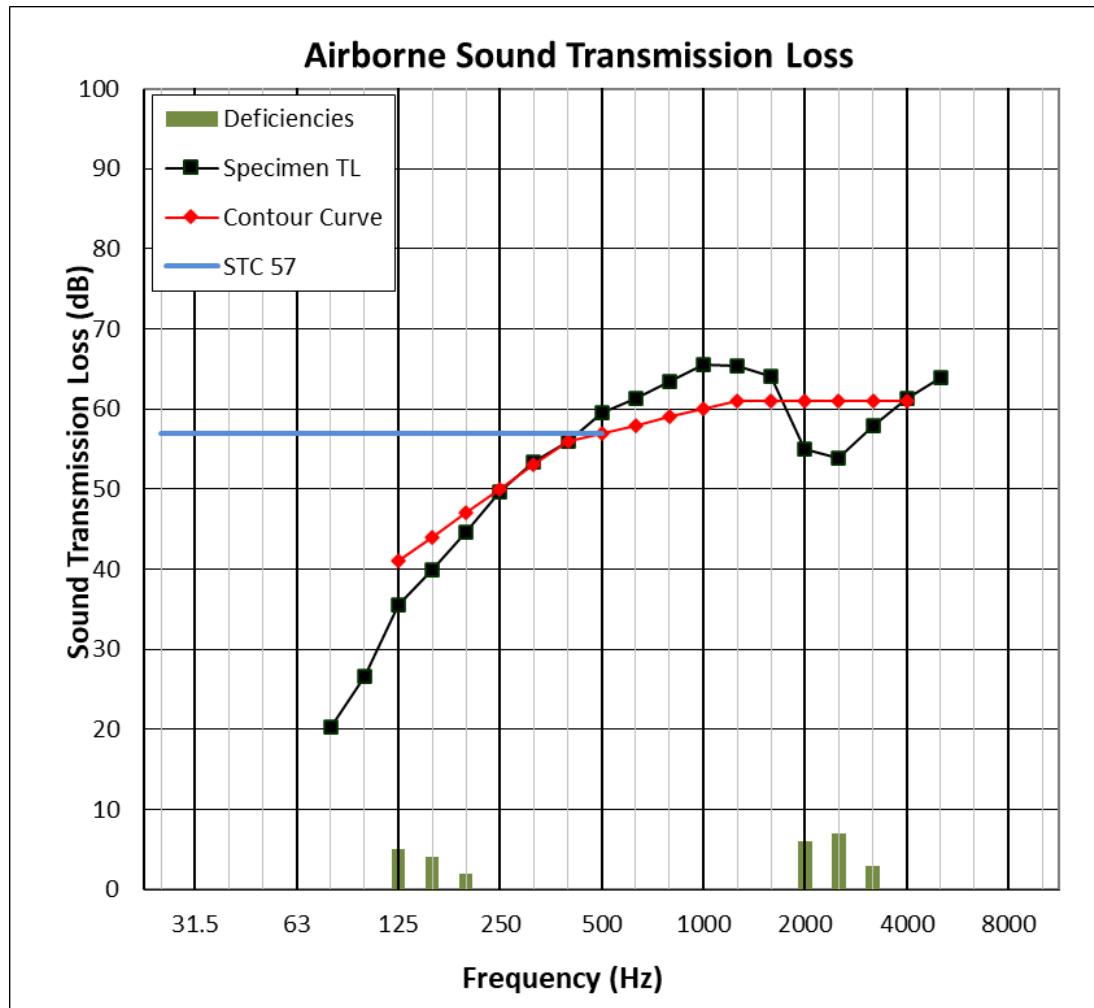
**ASTM E90  
AIRBORNE SOUND TRANSMISSION LOSS**

TEST DATE	02/26/21				
DATA FILE NO.	M0013.01				
CLIENT	California Expanded Metal Company (CEMCO)				
DESCRIPTION	3-5/8" Steel Studs spaced 24"OC with RC1-XD Resilient Channel on Interior spaced 24" OC, One Layer 5/8" USG Type X Source (screw spacing 8" on perimeter 12" in the field) / Two Layer 5/8" USG Type X Receive (screw spacing 12"OC)				
SPECIMEN AREA	13.01 m <sup>2</sup>	RECEIVE TEMP.	19.2 °C	SOURCE TEMP	19.2 °C
TECHNICIAN	Marco T San	RECEIVE HUMIDITY	43%	SOURCE HUMIDIT	43%

To obtain the Sound Transmission Class (STC), read the TL of the contour curve at 500 Hz. The sum of the deficiencies below the contour curve must not exceed 32. The maximum deficiency at any one frequency must not exceed 8.

FREQ (Hz)	BACKGROUND SPL (dB)	ABSORPTION (m <sup>2</sup> )	SOURCE SPL (dB)	RECEIVE SPL (dB)	SPECIMEN TL (dB)	95% CONFIDENCE LIMIT	NUMBER OF DEFICIENCIES
80	40.5	5.4	101	85	20	1.87	-
100	34.6	4.5	102	80	27	1.29	-
125	42.5	5.0	103	71	36	0.99	5
160	44.8	4.9	103	67	40	1.01	4
200	38.3	6.0	106	65	45	0.56	2
250	30.8	7.2	106	59	50	0.61	0
315	33.1	7.2	106	55	53	0.38	0
400	38.3	6.0	106	53	56	0.48	0
500	24.4	5.3	106	51	60	0.58	0
630	21.0	5.8	106	49	61	0.35	0
800	24.1	6.2	105	45	63	0.26	0
1000	16.7	6.3	107	45	66	0.24	0
1250	15.4	6.4	106	43	65	0.22	0
1600	6.6	6.9	103	42	64	0.24	0
2000	4.0	8.2	101	48	55	0.21	6
2500	3.8	9.3	101	49	54	0.21	7
3150	4.0	10.6	100	43	58	0.17	3
4000	4.7	13.0	97	36	61	0.28	0
5000	5.5	16.9	93	28	64	0.38	-
STC RATING	57	(Sound Transmission Class)					
DEFICIENCIES	27	(Sum of Deficiencies)					
OITC RATING	38	(Outdoor-Indoor Transmission Class)

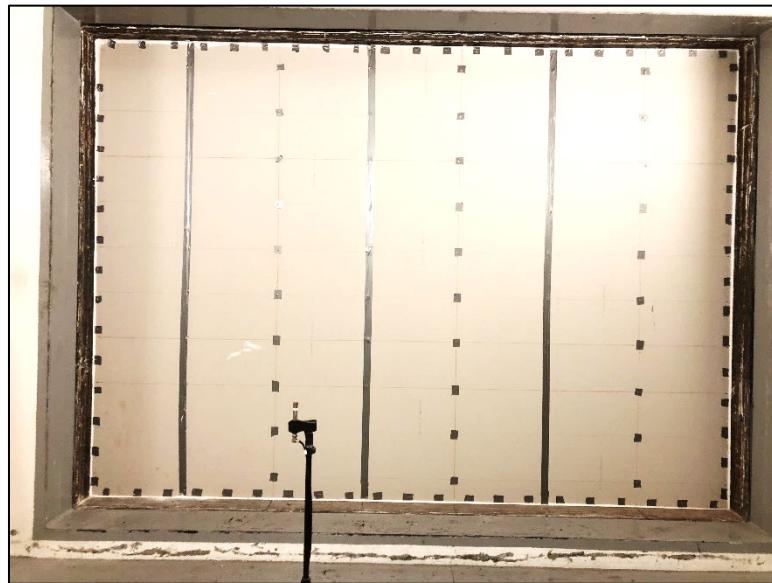
**Photo No. 1**  
**Source Room View of Test Specimen**

GYPSUM BOARD	One Layer USG 5/8" Type X				
STUDS	3-5/8" Steel, 24" Centers				
INSULATION	R-13 Fiberglass				
RESILIENT CHANNEL	CEMCO RC1-XD				
GYPSUM BOARD	Two Layers USG 5/8" Type X

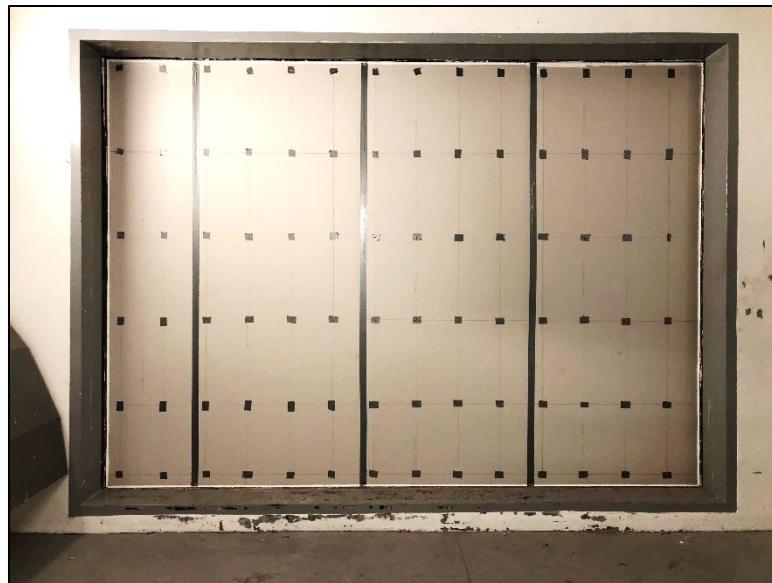
**Photo No. 2**  
**Receive Room View of Test Specimen**
